1. AGENCY USE ONLY (Leave blank)	2. REPORT DATE 1996	3. REPORT TYPE AND DATES COVERED Final Report		
4. TITLE AND SUBTITLE The Old Hospital Complex (5EP1778) Fort Carson, Colorado		5. FUNDING NUMBERS

13. ABSTRACT (Maximum 200 words) <p>The Old Hospital Complex (5EP1778) at Fort Carson, Colorado, consists of 59 buildings. The Complex was built during World War II and is significant due to its association with the history of the United States. The complex is semi-permanent construction, constructed from the Department of the Army's Series 800 plans. This report documents the complex in accordance with Section 1(g) of the Memorandum of Agreement enacted among the Department of the Army, Headquarters Fort Carson, the Colorado State Historic Preservation Office, and the Advisory Council on Historic Preservation.</p> <p style="text-align: center;">DTIC QUALITY INSPECTED 2</p>

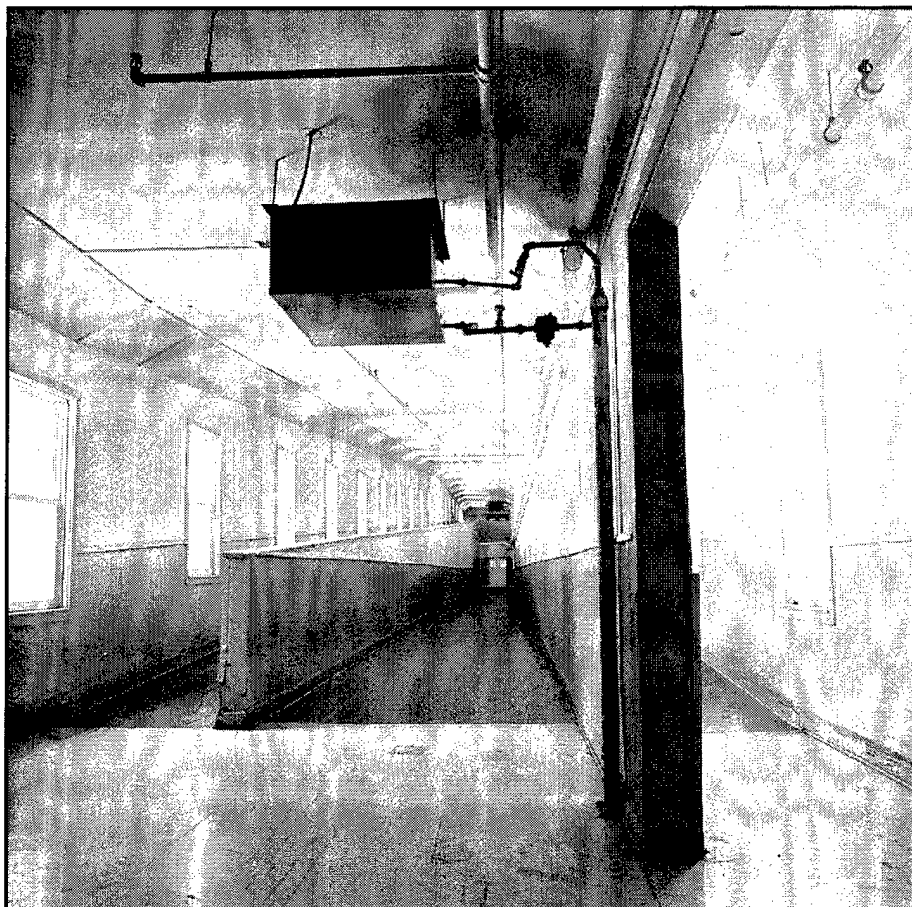
Figure V.212 SEP1778. Interior shot of ramp system and double corridor connecting Building S6251 to hospital complex. View to the north. 800 Series, Type H.C.WK.-A. Roll 2, Exposure 10.

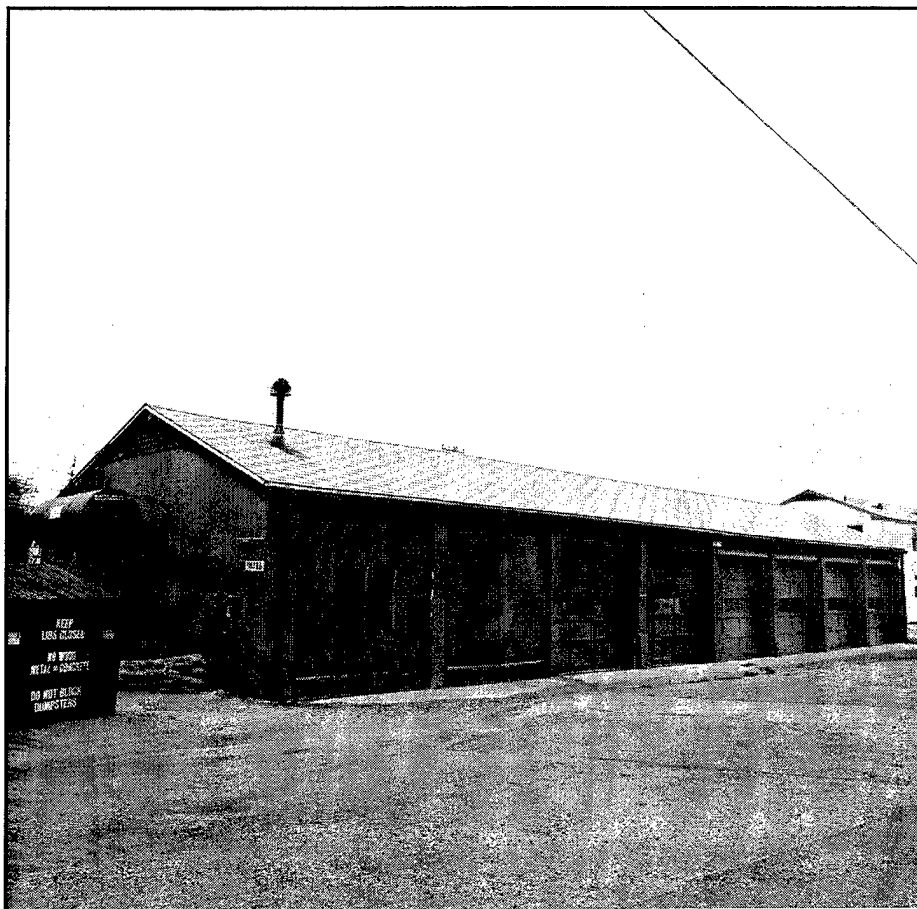
The building has a moderately pitched gable roof supported by wood-trussed rafters. There are triangular louvered vents under both gable peaks. A round metal chimney extends from the south slope, from above the westernmost vehicle bay. Boxed eaves overhang 6" on the eave sides. Gable walls have subtle cornice returns at the eave line. Cornice bands consist of single 1" x 12" boards topped with a strip of crown molding. The building's original mineral-surfaced shingle roofing has been replaced with three-tab asphalt shingles.

Figure V.216 5EP1778. Building S6288, Garage, 800 Series, Type HG-8. Three-quarter view of south and west faces. Roll 7H, Exposure 11.

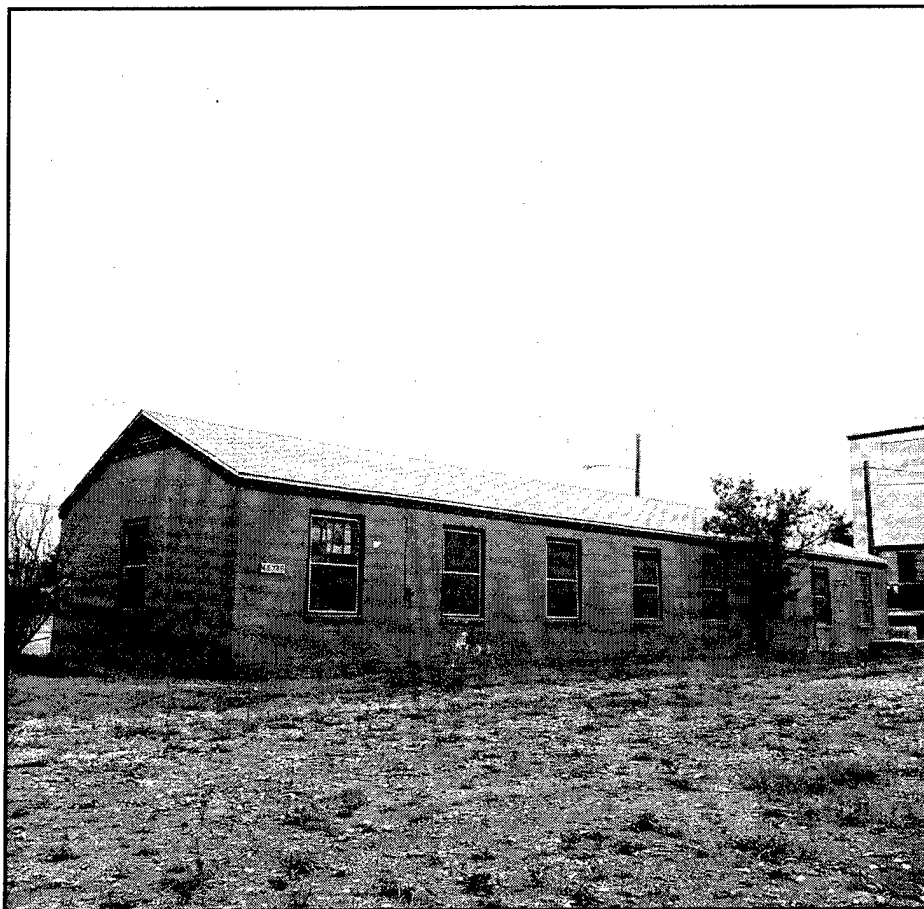
Figure V.217 5EP1778. Building S6288, Garage, 800 Series, Type HG-8. Three-quarter view of east and north faces. Roll 7H, Exposure 3.

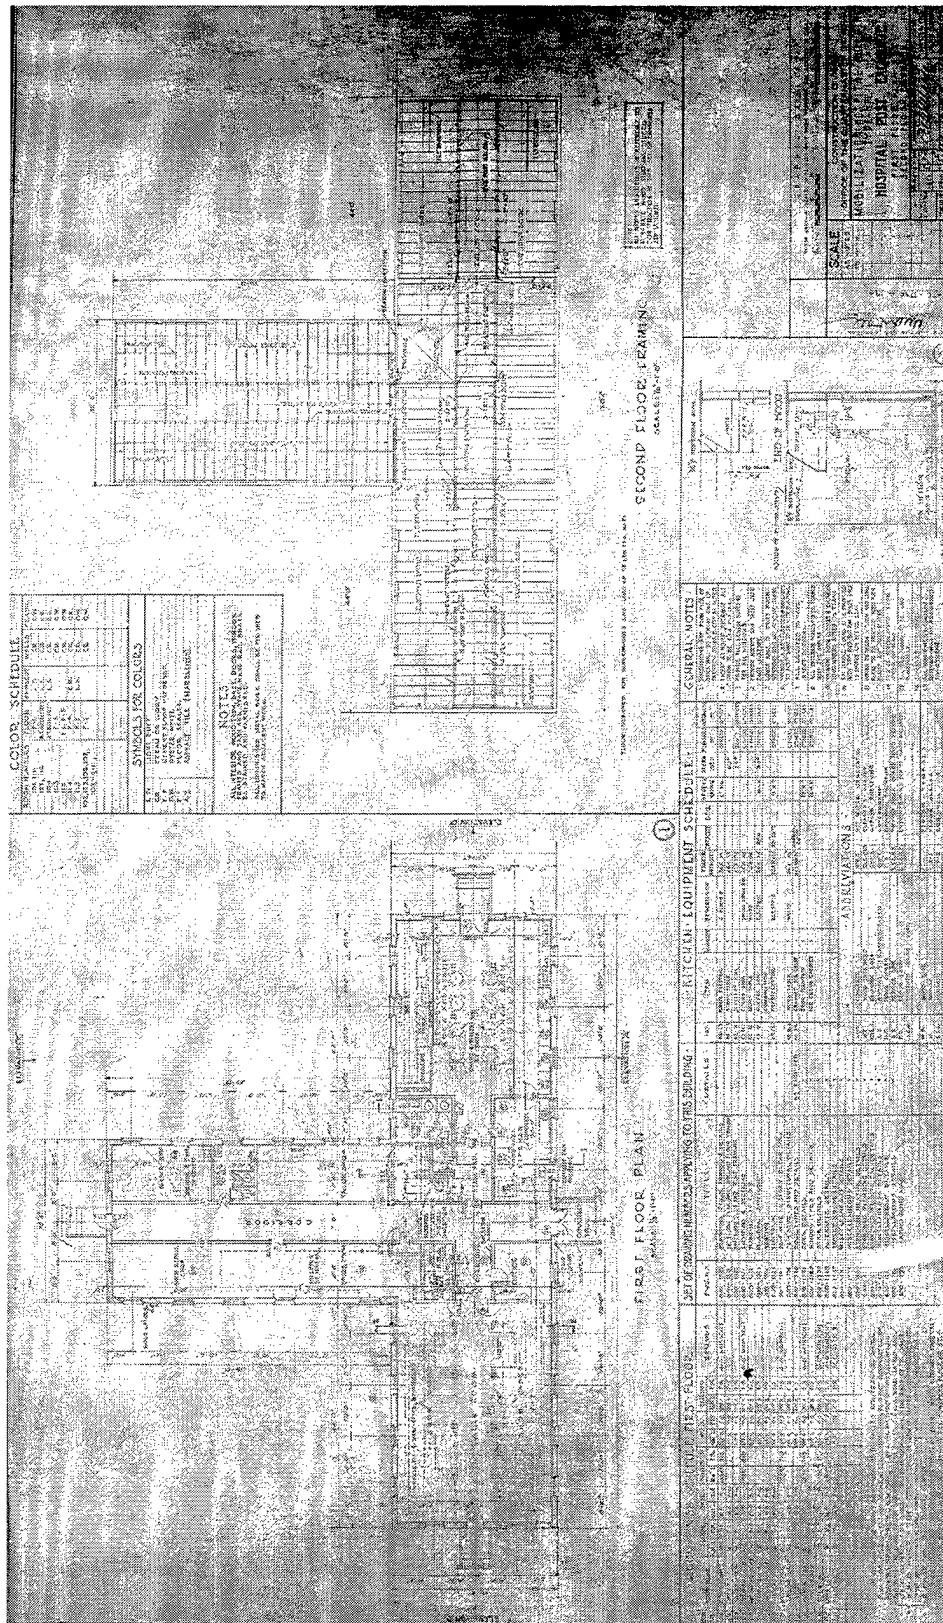
Figure V.218 5EP1778. First-floor plan and second-floor framing plan for Building S6261, Hospital Post Exchange, 800 Series, Type HPE-1, Plan 800-1819.

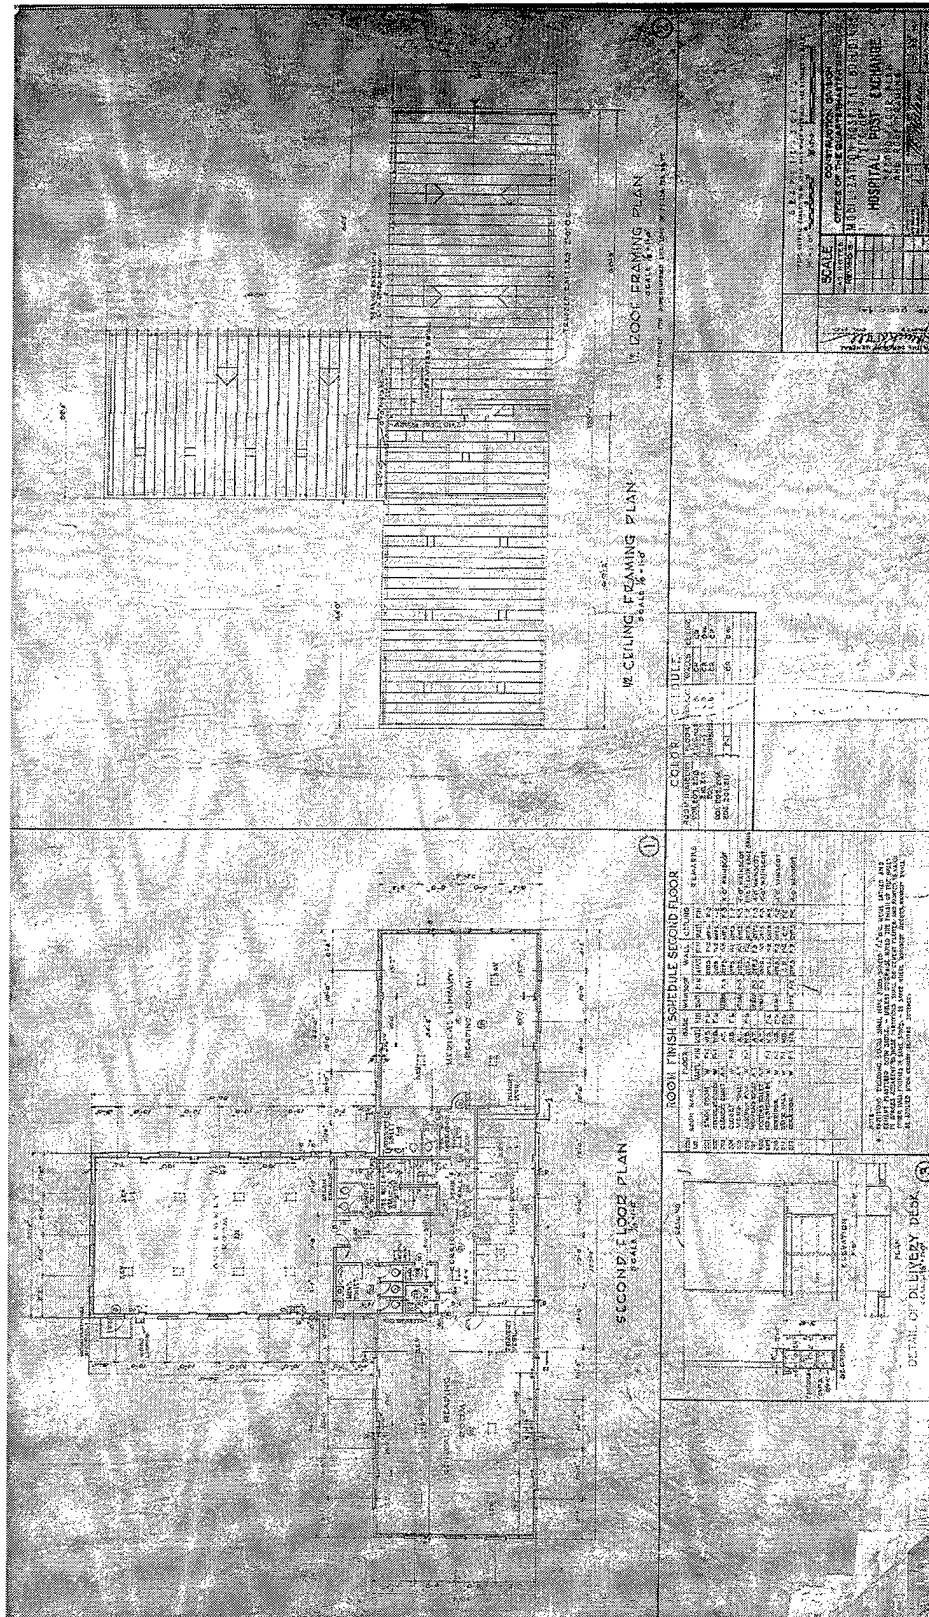
Figure V.219 5EPI778. Second-floor plan and roof framing plan for Building S6261, Hospital Post Exchange, 800 Series, Type HPE-1, Plan 800-1820.

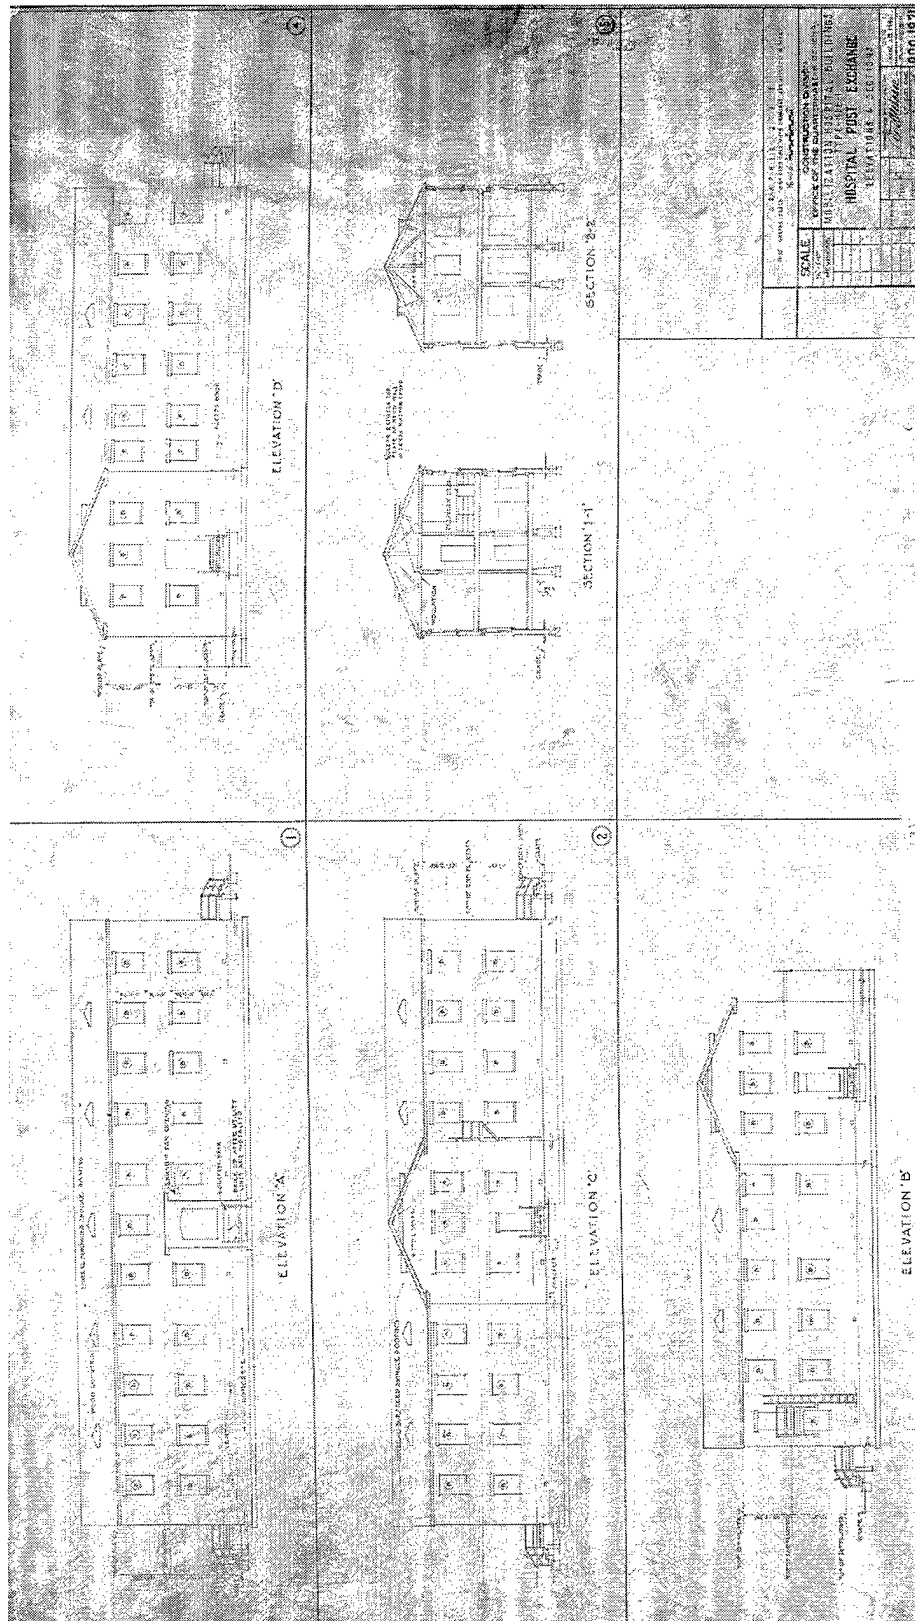
Figure V.220 5EP1778. Elevations and sections for Building S6261, Hospital Post Exchange, 800 Series, Type HPE-1, Plan 800-1821.

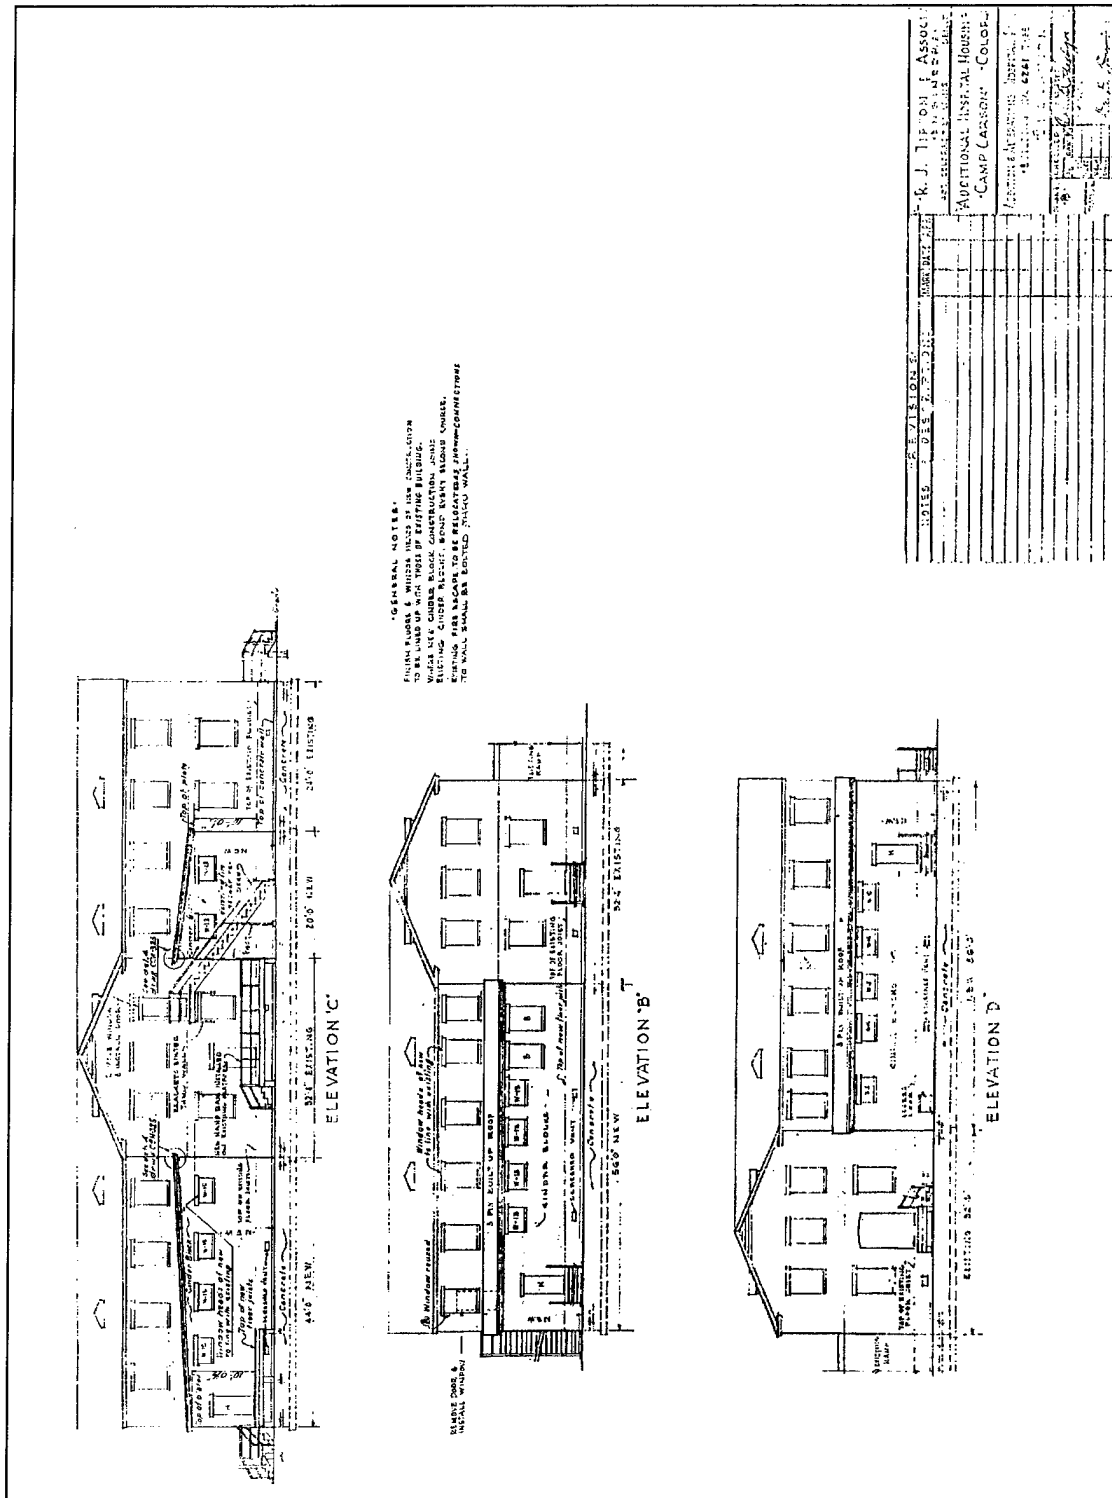
Figure V.221 5EP1778. Elevations and sections for Building S6261, Hospital Post Exchange, CCH Series, Sheet (illegible).

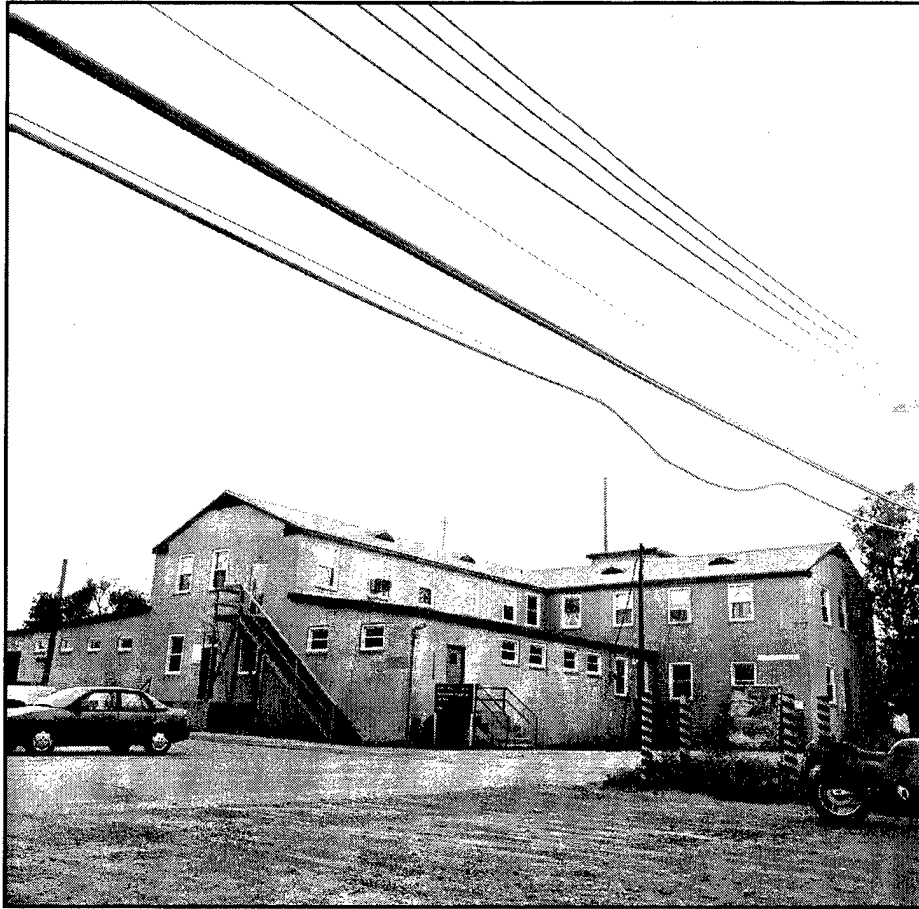
Figure V.224 5EP1778. Building S6261, Hospital Post Exchange, 800 Series, Type HPE-1. Three-quarter view of north and east face. Roll 6H, Exposure 3.

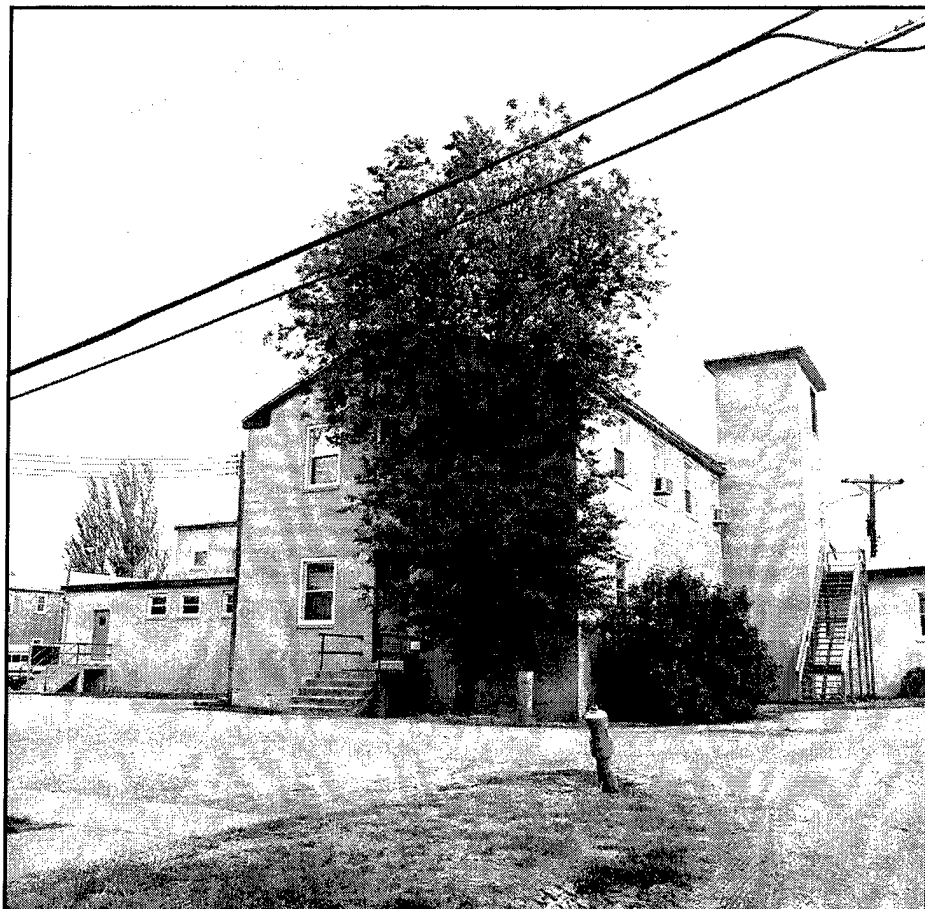
Figure V.225 5EP1778. Building S6261, Hospital Post Exchange, 800 Series, Type HPE-1. Three-quarter view of north side's north and west faces. Roll 6H, Exposure 8.

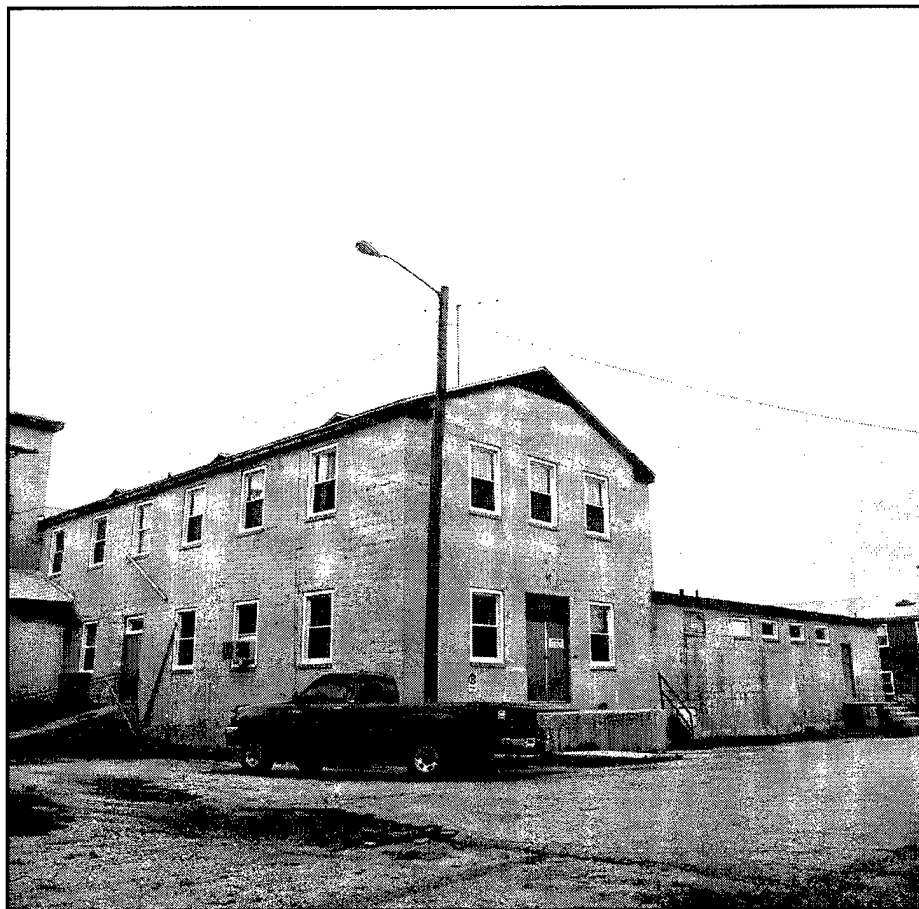
Figure V.226 5EP1778. Building S6261, Hospital Post Exchange, 800 Series, Type HPE-1. Three-quarter view of south side's south and west faces. Roll 5H, Exposure 7.

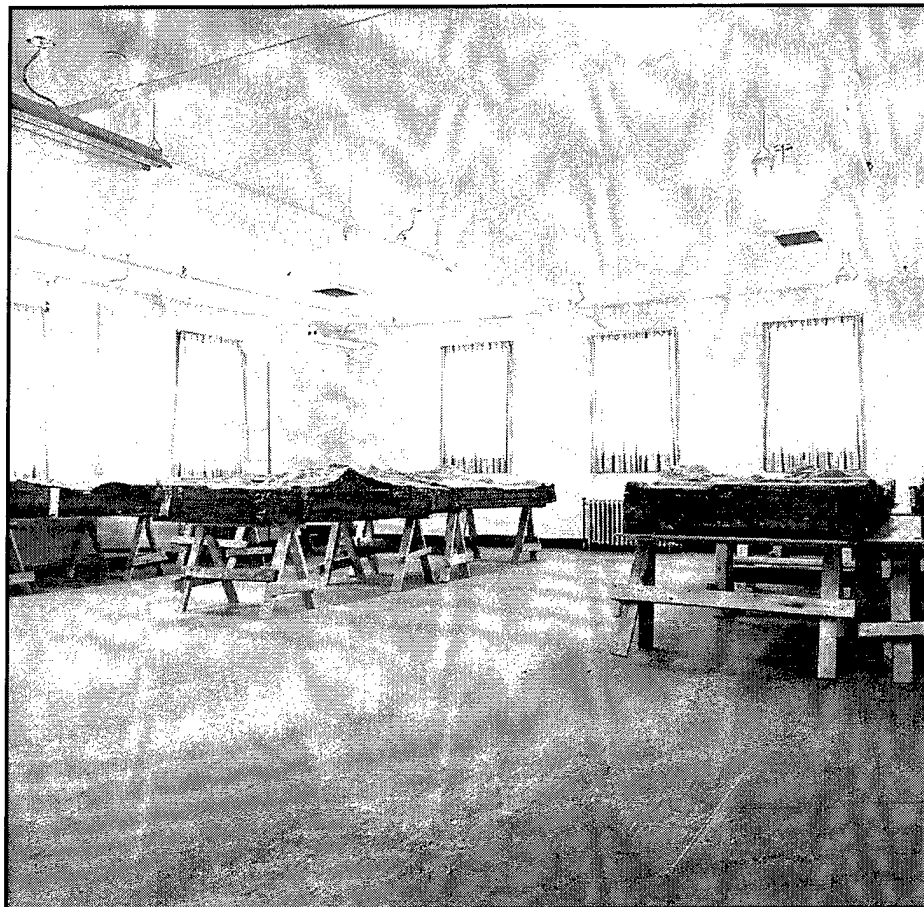
Figure V.227 5EP1778. Building S6261, Hospital Post Exchange, 800 Series, Type HPE-1. Interior shot of large room, second floor south side, facing southeast, Roll 3H, Exposure 4.

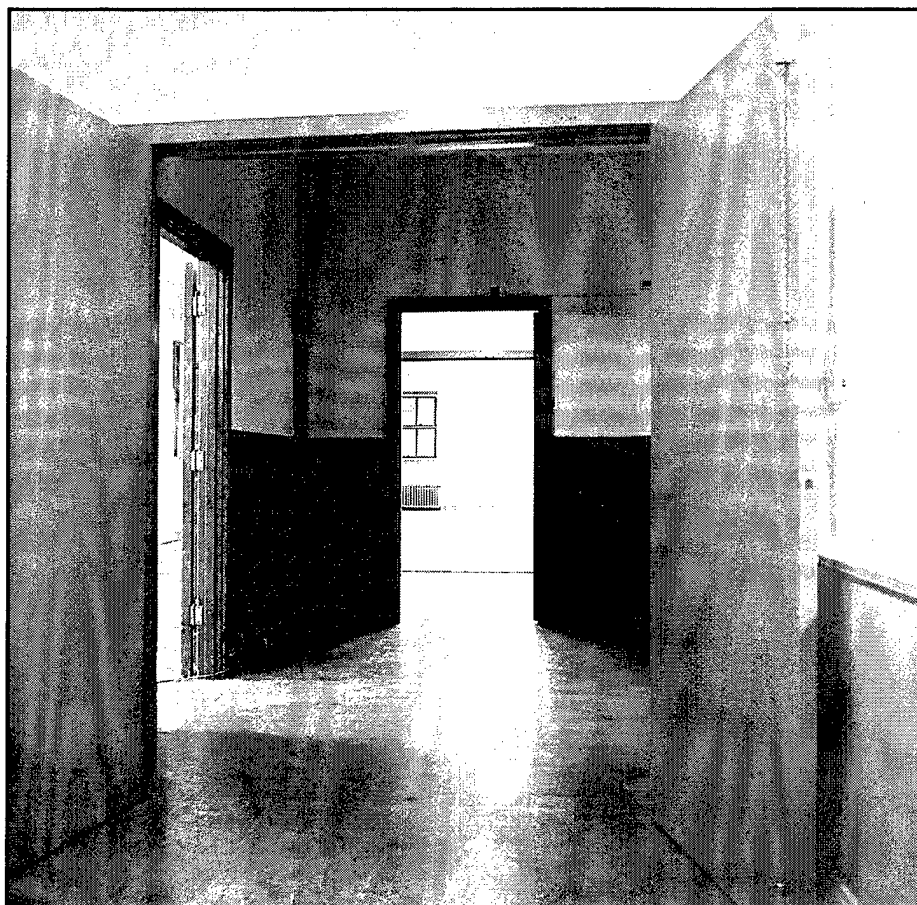
Figure V.228 5EP1778. Building S6261, Hospital Post Exchange, 800 Series, Type HPE-1. Interior shot of second floor, with view of top of stairs to the north. Roll 3H, Exposure 7.

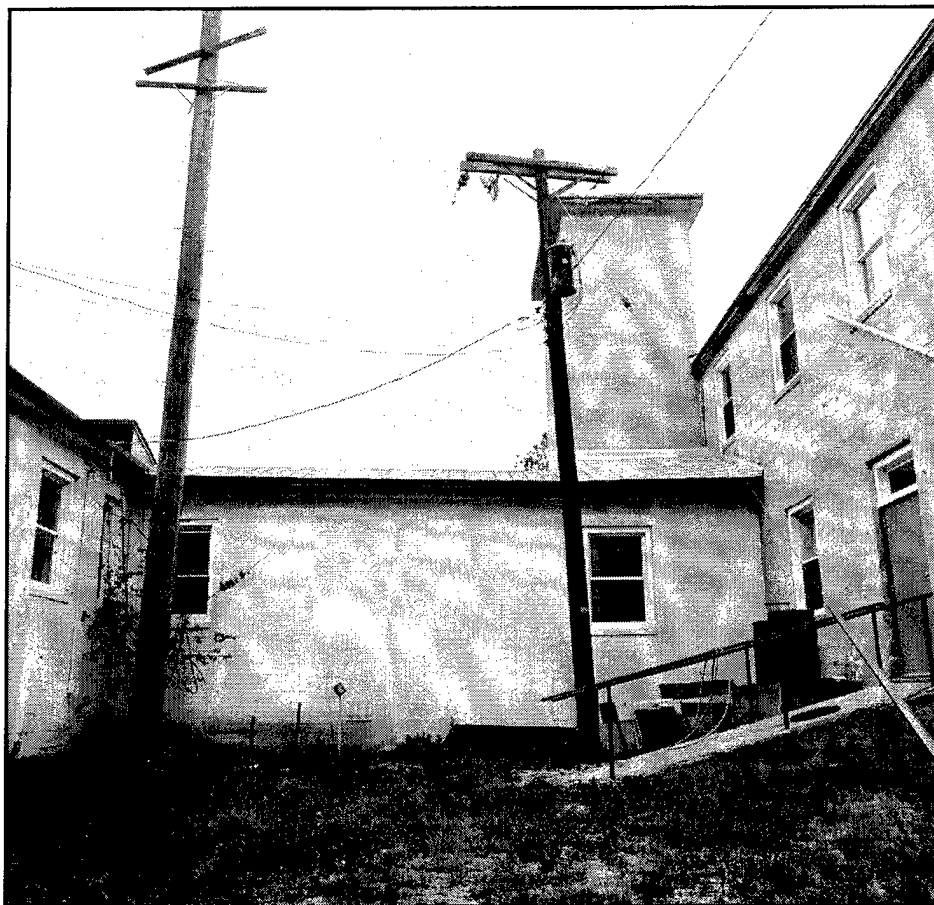
Figure V.229 5EP1778. South face of corridor connecting Buildings S6260 and S6261. 800 Series, Type H.C.WK.-A. Roll 5H, Exposure 4.

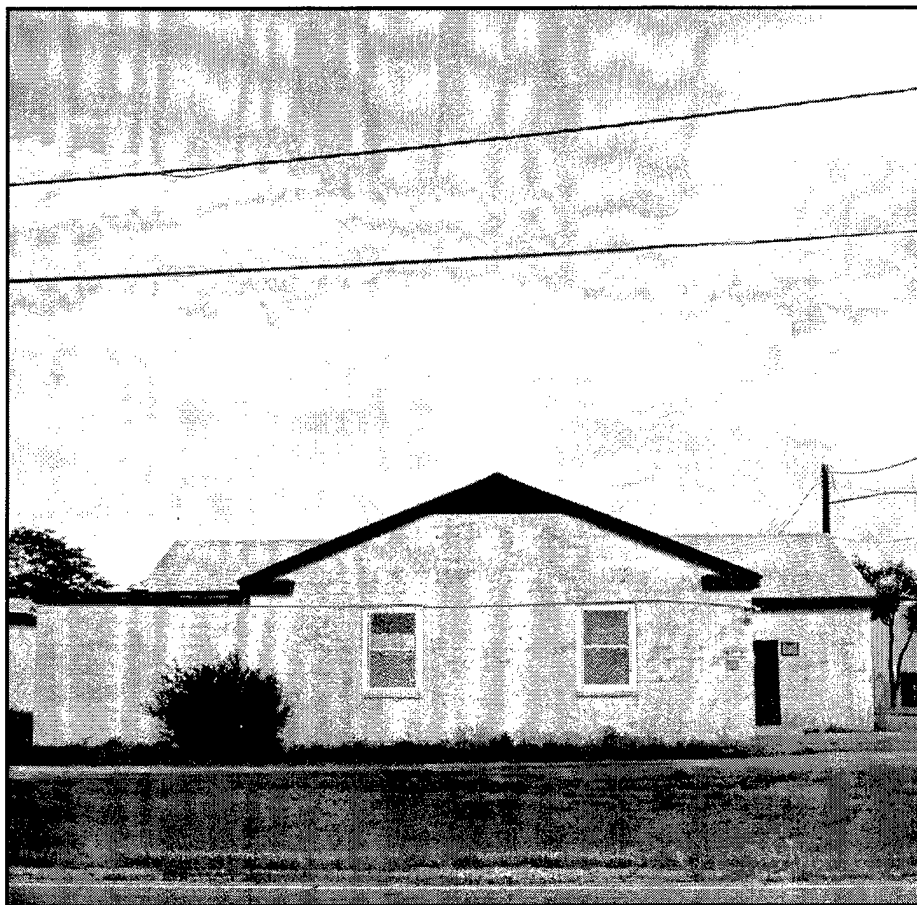
Figure V.231 5EP1778. Building S6273, Morgue, 800 Series, Type HMO-1. West face. Roll 14F, Exposure 3.

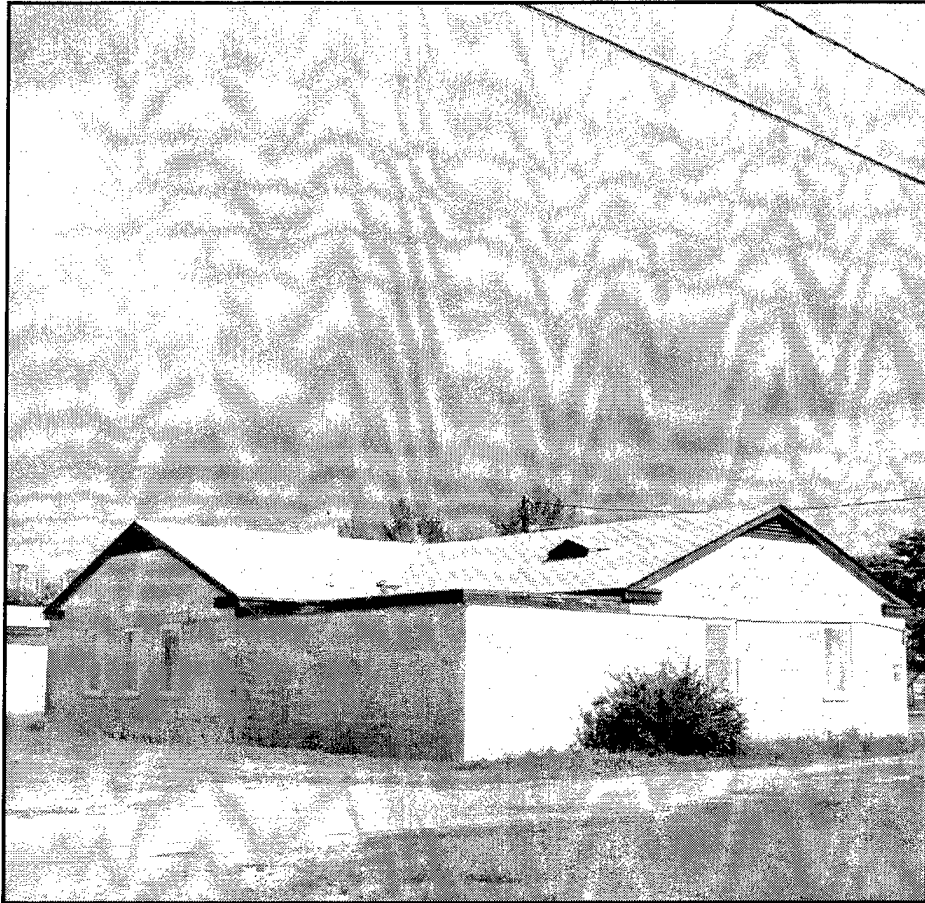
Figure V.232 5EP1778. Building S6273, Morgue, 800 Series, Type HMO-1. Three-quarter view of north and west faces. Roll 14F, Exposure 5.

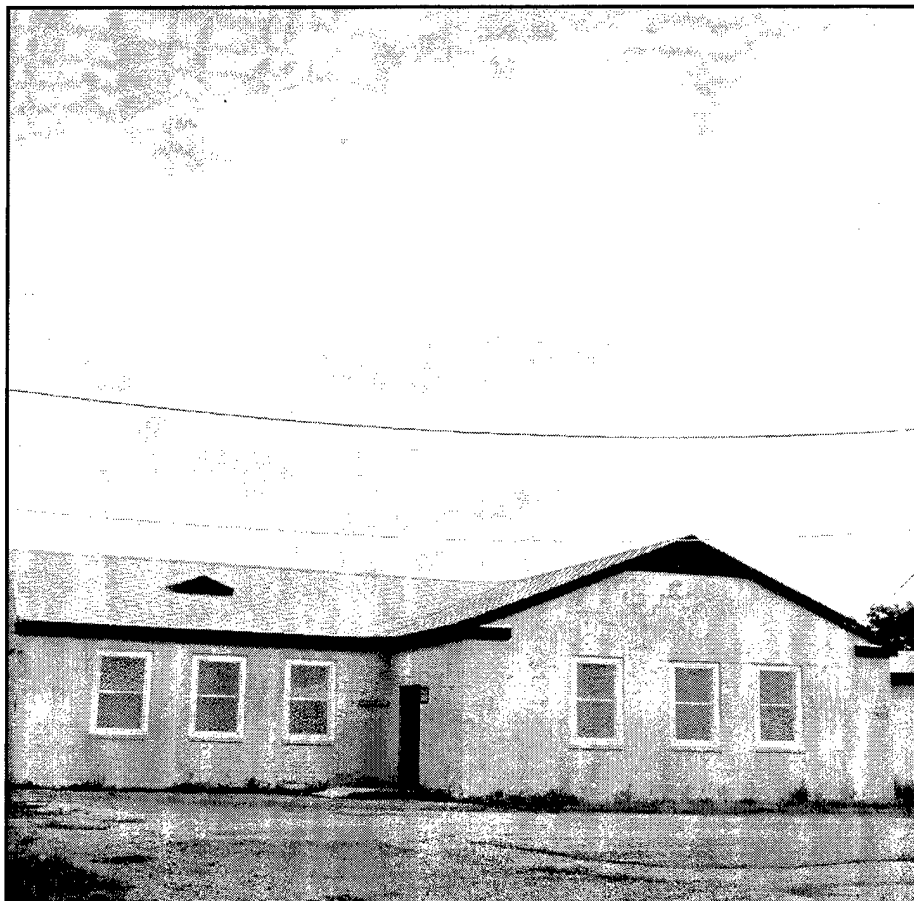
Figure V.233 5EP1778. Building S6273, Morgue, 800 Series, Type HMO-1. Three-quarter view of south and west faces. Roll 10F, Exposure 10.

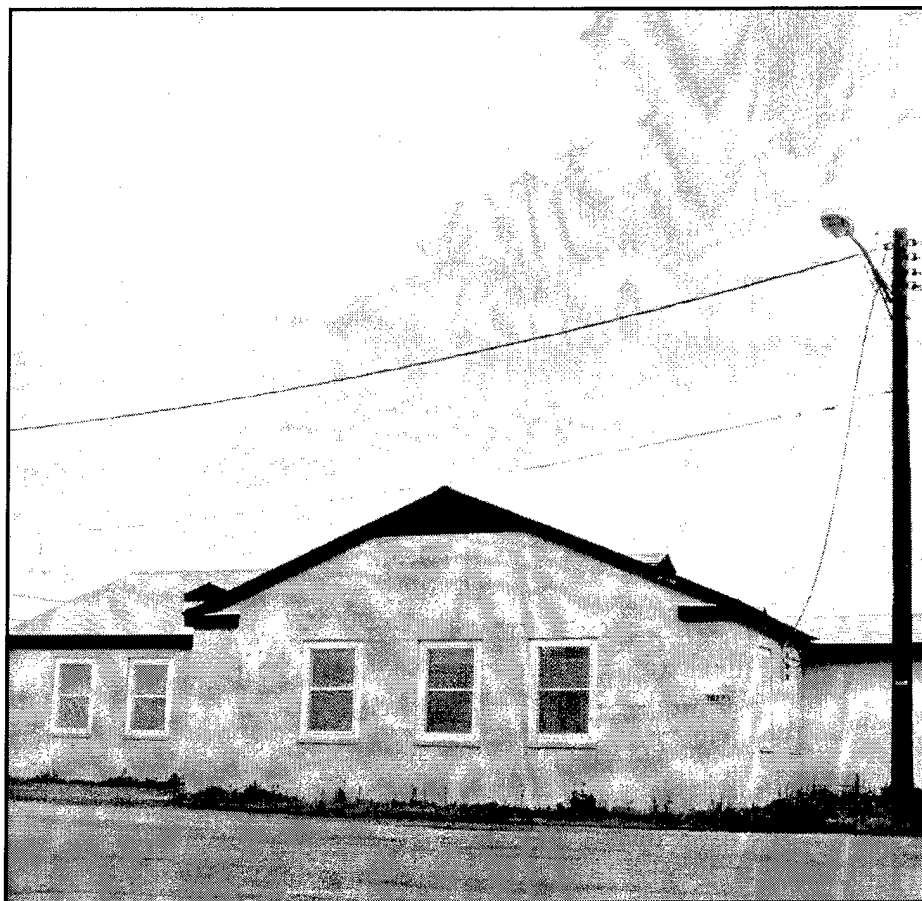
Figure V.234 5EP1778. South face, including corridor connecting Buildings S6273 and S6274. 800 Series, Type H.C.WK.-A2. Roll 10F, Exposure 4.

In 1978 the building's incandescent lighting was replaced with fluorescent. In 1986 a wood-frame gable roof was constructed over the original flat roof of the corridor that links S6273 with S6274 and the remainder of the OHC. In 1987-1988 most original windows at the OHC, including those of this building, were replaced with aluminum clad one-over-one light double-hung windows. The 1992 functional re-designation to a storehouse was accomplished without building alteration.

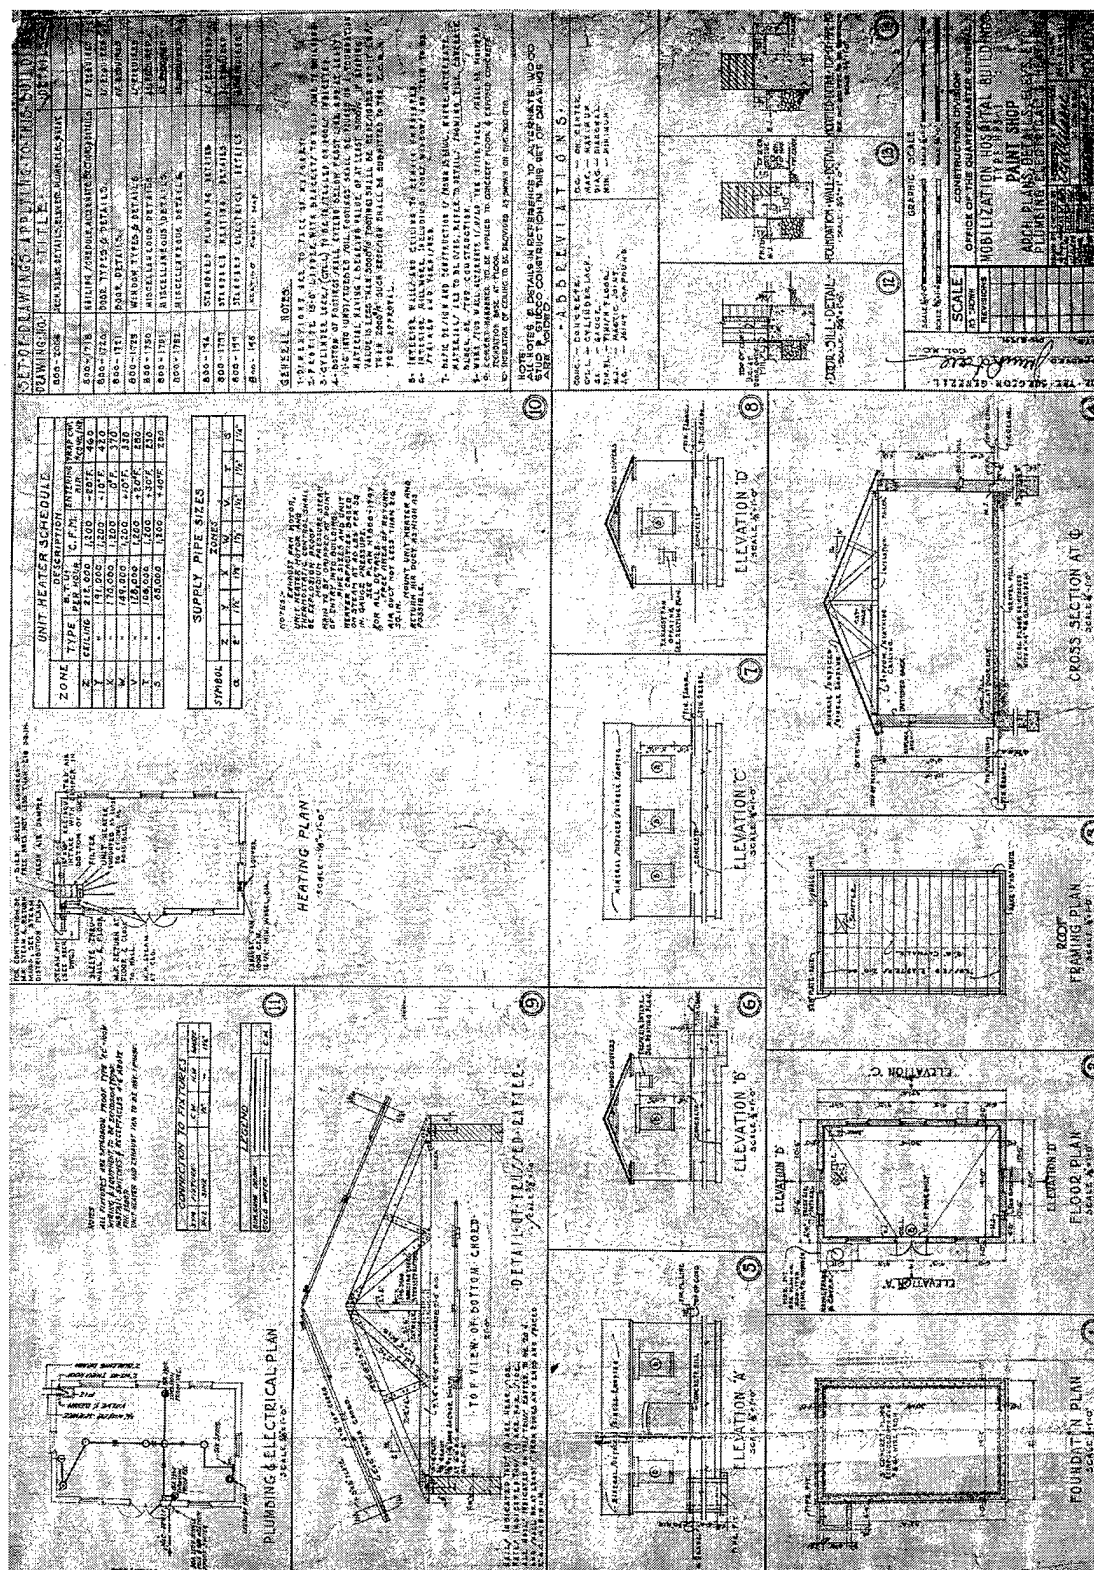
Figure V.235 5EPI778. Architectural plans, details, and elevations for Building S6275, Paint Shop, 800 Series, Type HPS-I, Plan 800-2006.

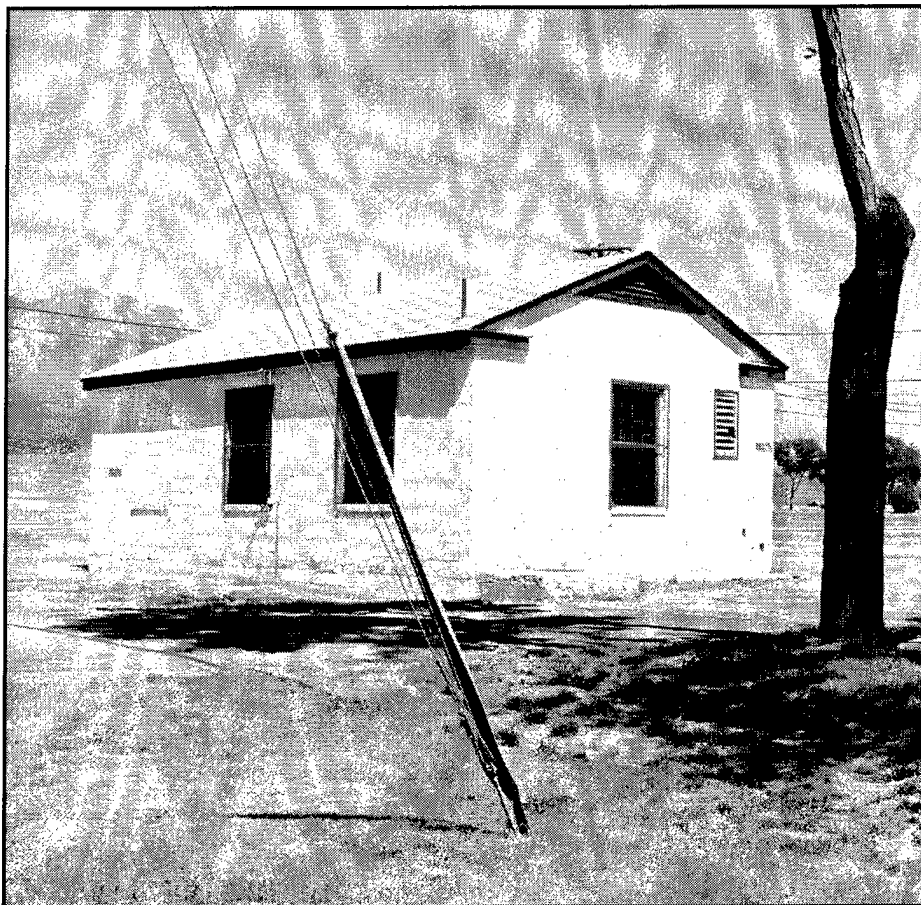
Figure V.236 5EP1778. Building S6275, Paint Shop, 800 Series, Type HPS-1. Three-quarter view of south and east facades. Roll 7, Exposure 2.

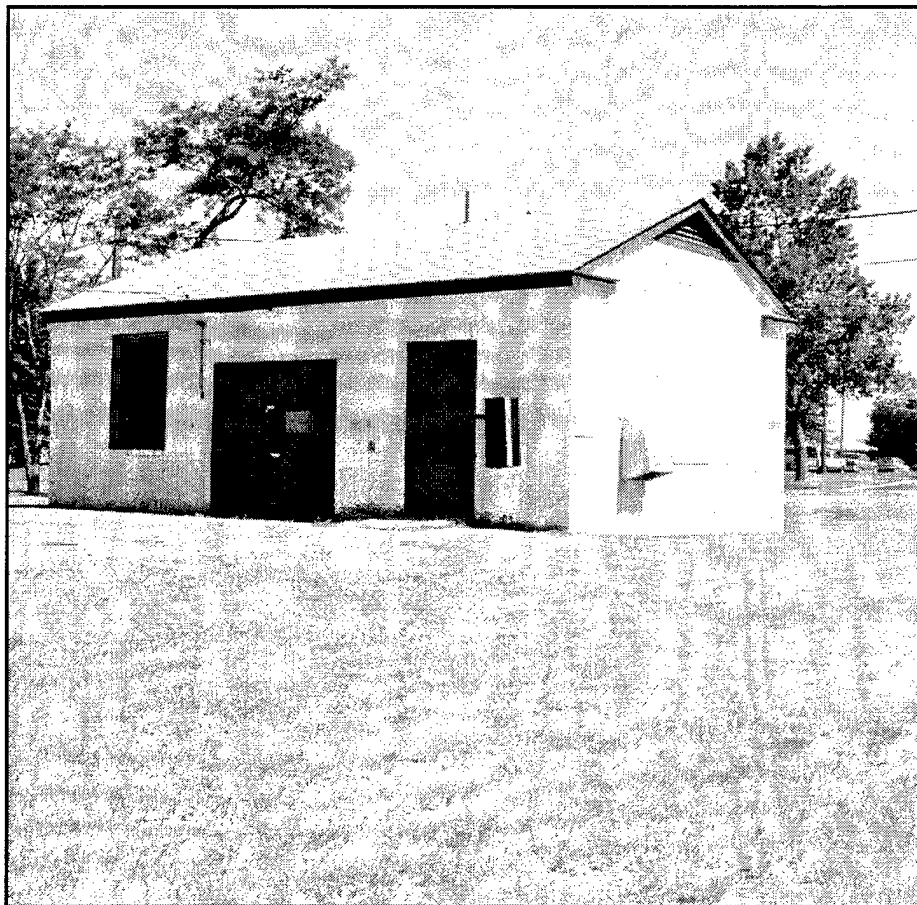
Figure V.237 5EP1778. Building S6275, Paint Shop, 800 Series, Type HPS-1. Three-quarter view of north and west facades. Roll 11, Exposure 4.
